Re: Big Creek Dams (B-28A and B) – Inspection Summary

Big Creek # 1 (B-28 A)

Big Creek 2 (B-28 B)

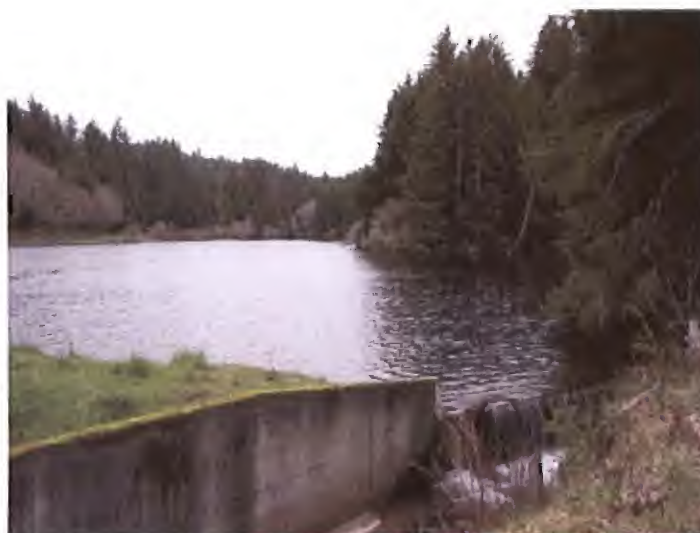
Spillway approach

The approach to the spillway is generally clear. There were no logs or debris at the approach or in the reservoir near the dam. There is no log boom, so cleaning the reservoir after a major windstorm would be necessary to protect spillway function.

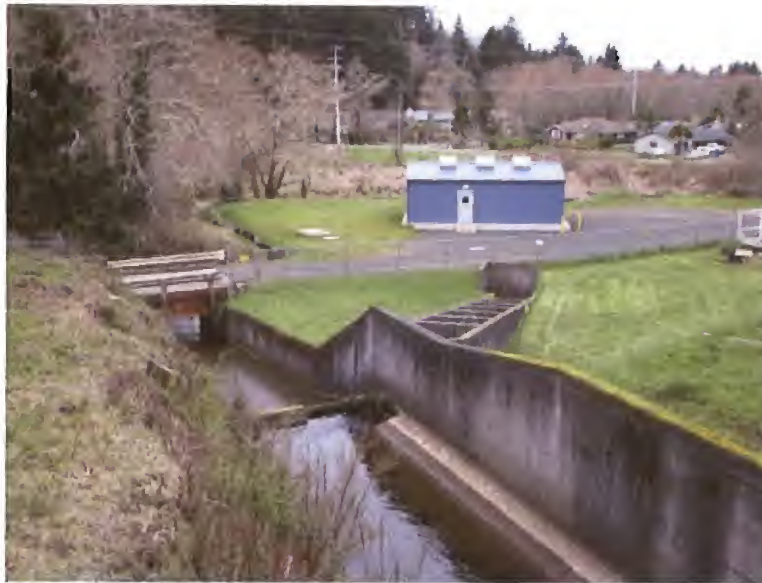
Spillway control and discharge with fish ladder

The concrete in the control section and down to the discharge was examined. The spillway shows no distress and appears fully functional.

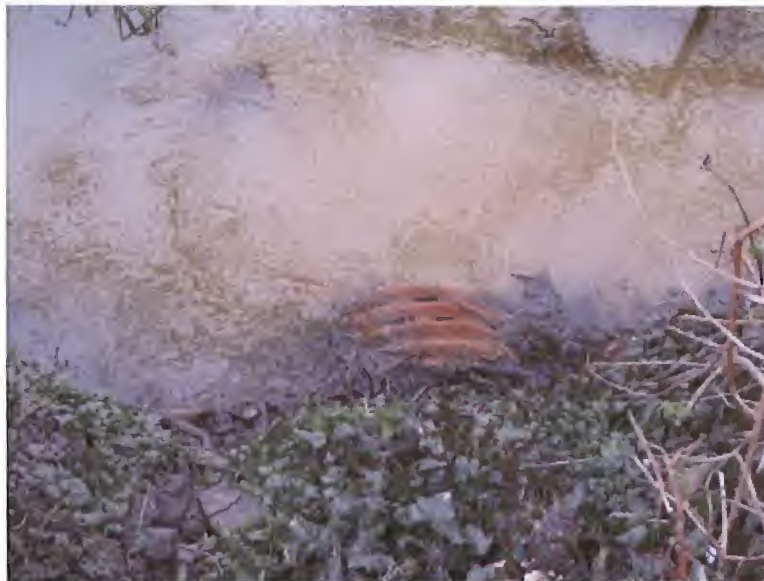
Discharge of low level conduit

I did receive designs for the new conduit from Civil West Engineering. However, they had no information on the current gate structure or trash rack. The plan is to install a 24 inch HDPE liner, with grouting of annular spacing. This is a short term priority for the dam, as is installing an effective gate for this low level conduit.

- 1) Watch the small seep in the middle of the dam, and notify me if flow becomes measurable.
- 2) Notify me when the conduit is repaired and ensure repairs address the gate and provide a likelihood of continued operation after an earthquake.

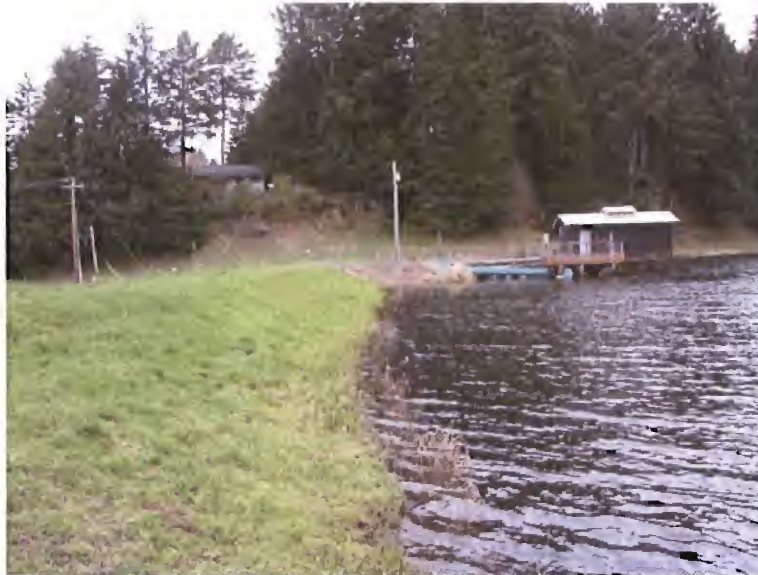
Upstream face and control works

The upstream face has a full cover of grass, and shows no signs of wave erosion or other distress. Minimum freeboard was 5 feet, which is very good for a 21 foot high dam. There is no significant debris in the reservoir.

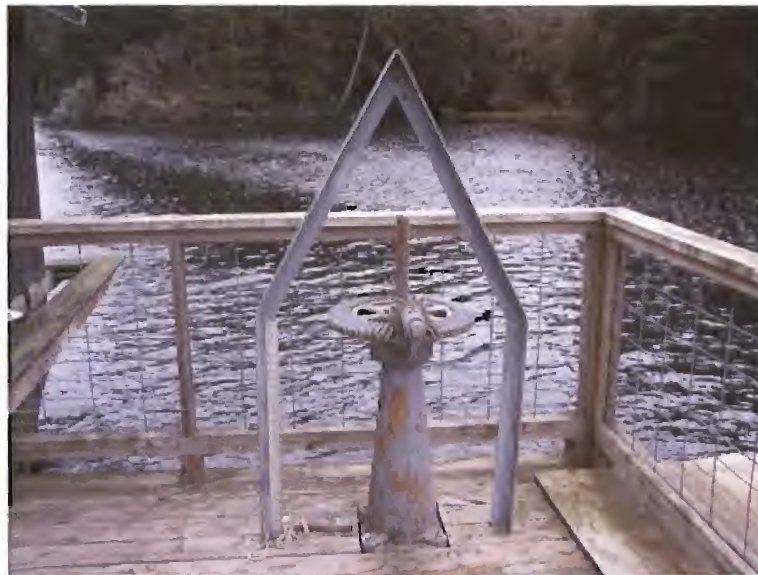
Control stem

This control stem may be very important in a seismic event. At the present time, I am unsure of its condition or operation. It is very important to ensure this structure is robust and functional during the work to re-line the low level conduit.

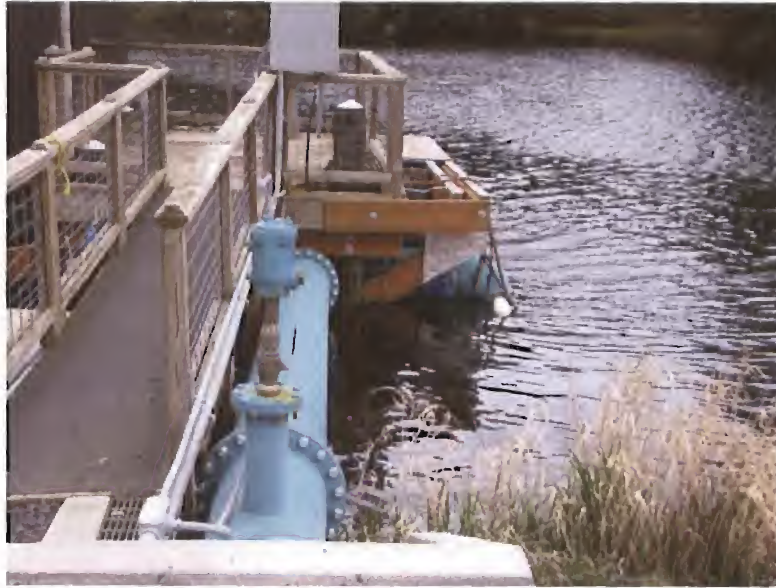
Intake to water treatment plant

This is the intake structure for the water treatment plant. Improvements to this structure necessitated the geotechnical boring and are the reason the seismic issues were discovered. The previous inspection of this dam was conducted during the borehole drilling and seismic cone penetrometer testing.

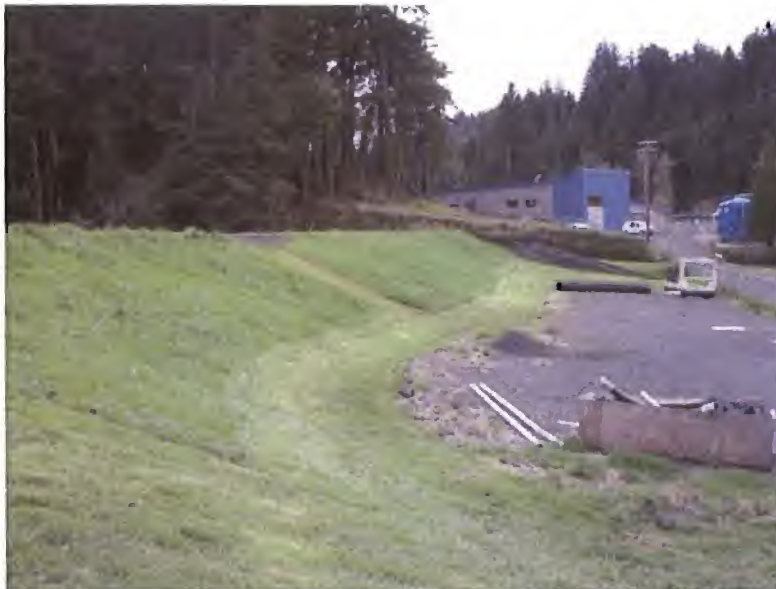
Downstream face

There is a dense cover of grass effectively preventing erosion on the downstream face of the dam. There is no woody vegetation growing on the dam or on the abutments. The toe of the dam is covered by a large berm which appears to be quite important to the seismic stability of the dam. Seismic stability is still marginal even with the berm, however.

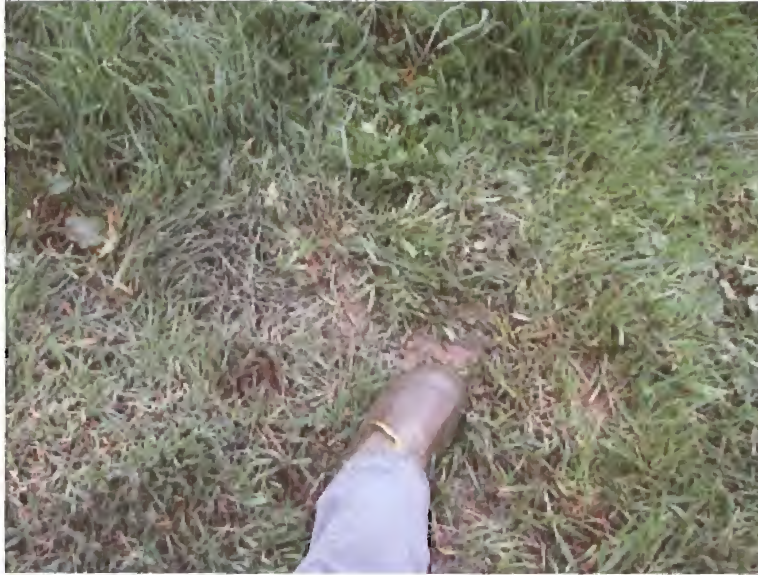
Small area of seepage

The wet area above was just above the toe of the dam, near the center. There was no measurable flow, and for now it is just a watch issue. I will reexamine this site the next time I am at the lower dam.

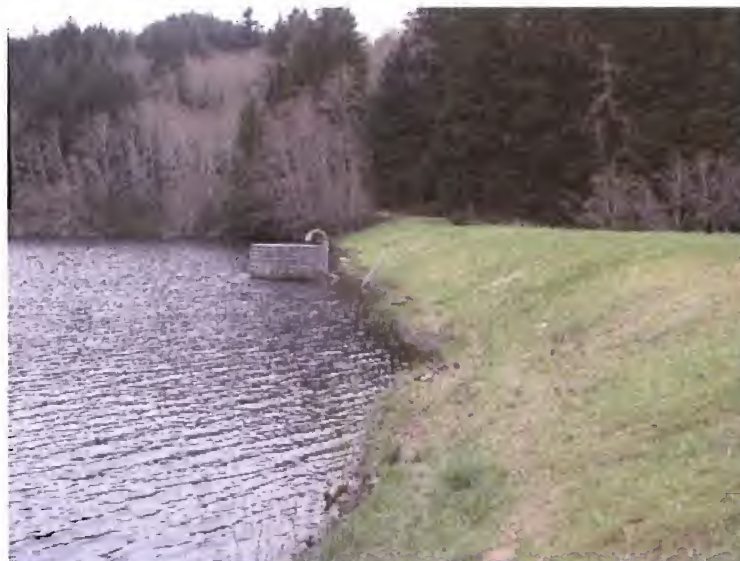
Upstream face and spillway intake

Upper Big Creek dam has a reasonable grass cover on the upstream face and crest. These locations show no signs of significant wave erosion or any movement. The dam had a minimum of 8.5 feet of freeboard for the past winter, which is also very good.

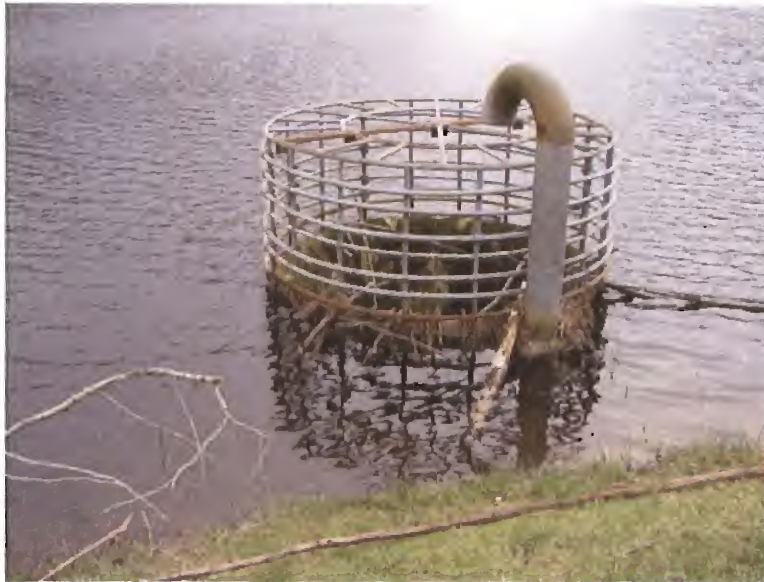
Trash rack for morning glory spillway

The principal spillway is a morning glory structure. The trash rack for this structure has a small amount of debris on the grates and floating around the structure.

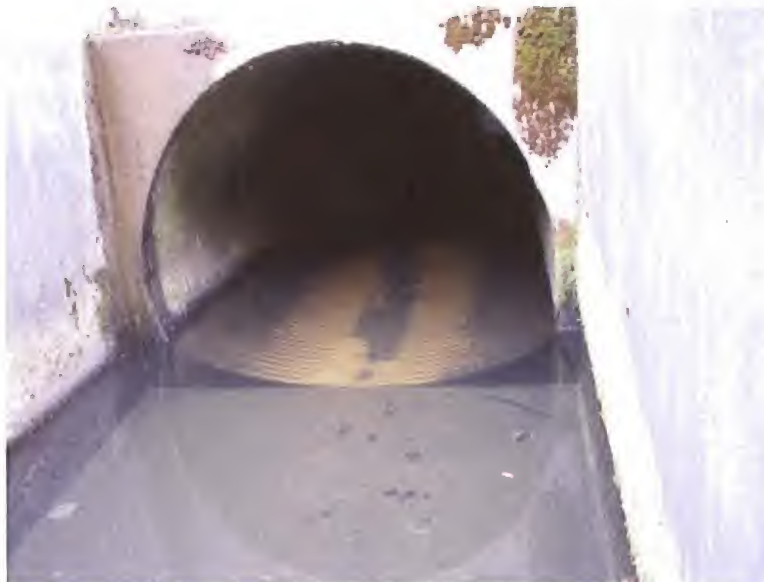
Outlet of principal spillway

The spillway conduit is a corrugated metal culvert. There was no significant corrosion observed in the culvert but it was only viewed from outside. A view inside this culvert will be attempted during the next routine dam inspection.

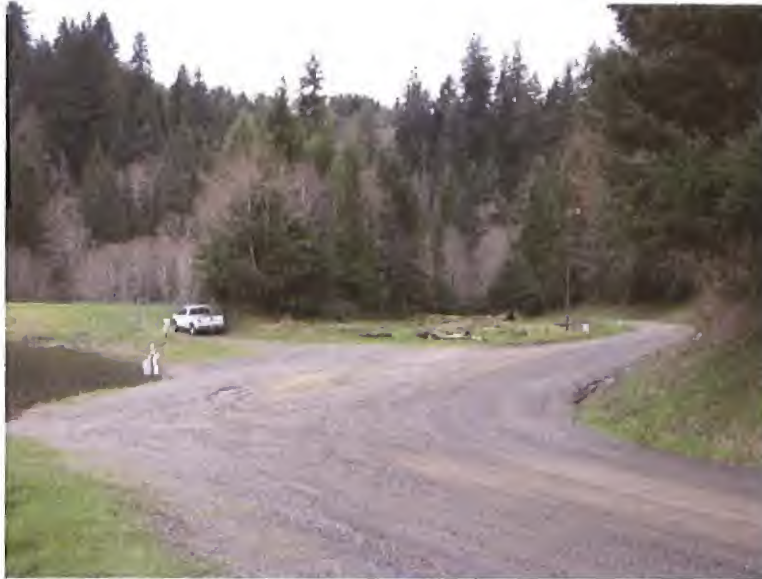
Emergency Spillway

The access road serves as a functional emergency spillway for Big Creek # 2 dam, and appears to provide more spillway capacity than the lower dam's spillway.

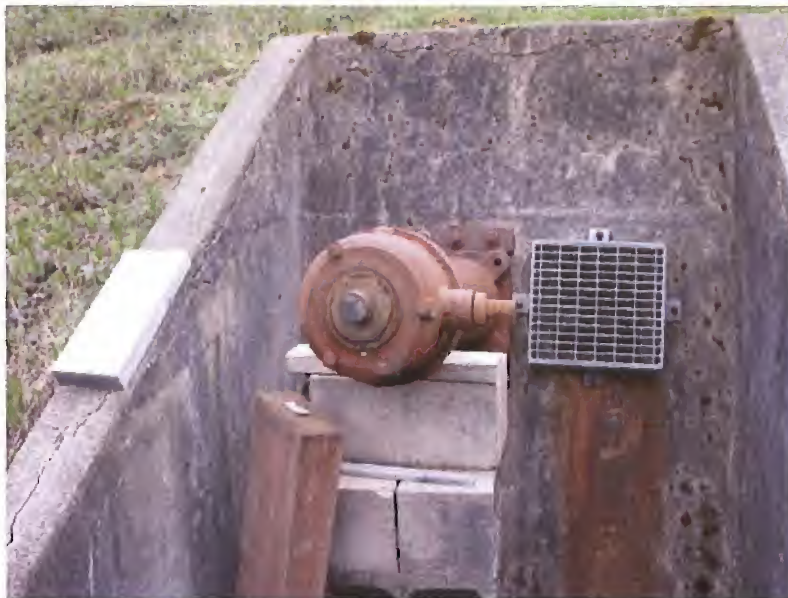
Control stem with air vent

The control for the low level conduit is supported by an unorthodox and unsecure combination of concrete blocks and boards. It is not sturdy, especially if there is an earthquake. The control stem and structure are both rusty. A permanent and seismically resistant support is essential, in addition to maintenance. Operation of the low level conduit may be essential after an earthquake, with no time available for repairs.

- 1) Provide permanent support to the control stem and improve its maintenance.
- 2) Install a weir box to collect and monitor flow from the right abutment.

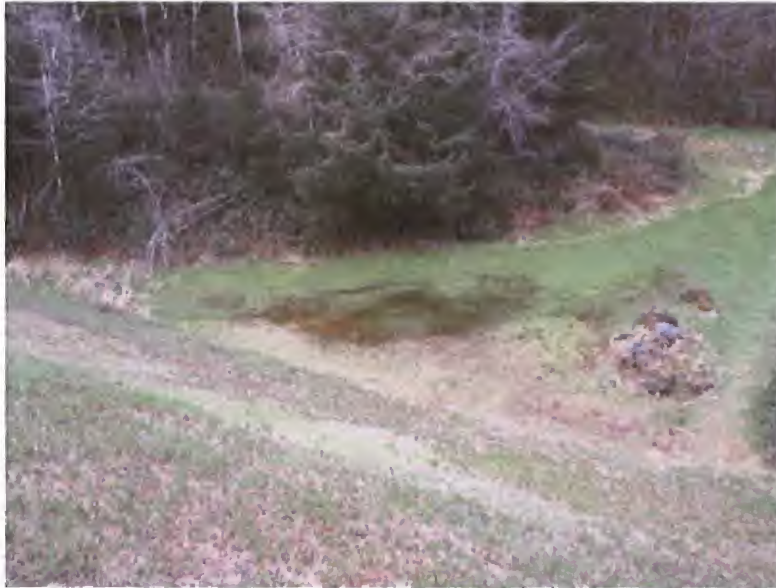
Wet area at toe of dam

The toe of this dam is wet for most of our inspections. I detect no change from inspections at similar water level, nor is there measurable flow leaving this location.

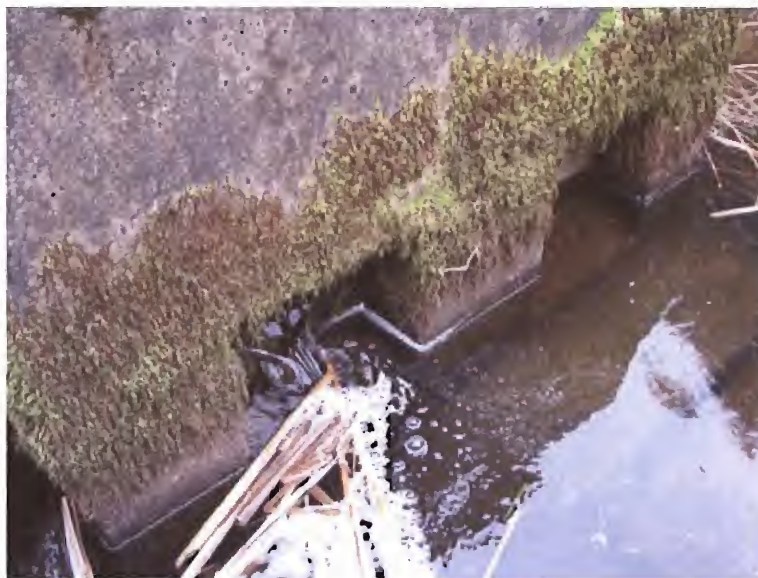
Toe drains

The toe drains seem to be functional. However, the weirs are generally not effective because of downstream high water levels or physical damage.

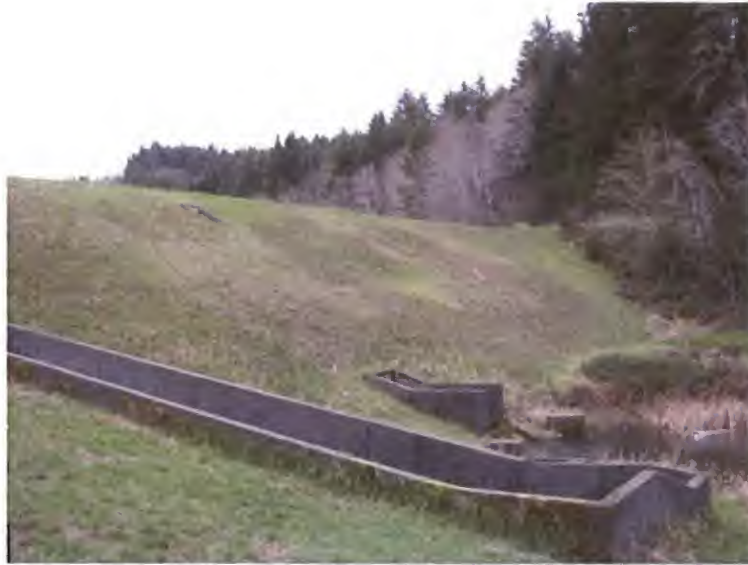
Downstream face with fish ladder

The downstream face was a little light on grass cover, but there was no erosion or signs of movement observed.

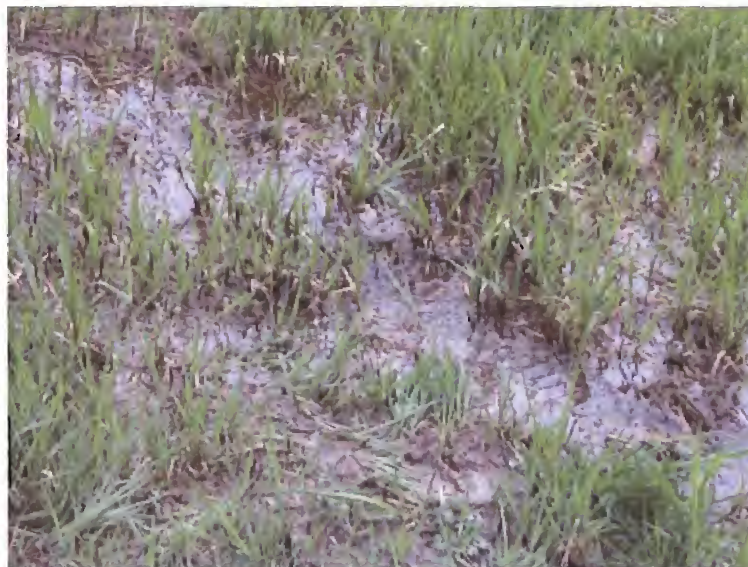
Area of seepage below right abutment

There is one area of seepage below the right abutment. It was also observed in the previous inspection. This seepage bypasses a weir box, as the culvert for that drain is mangled. There is enough water that it should be monitored with a weir box to see if the flow changes.
